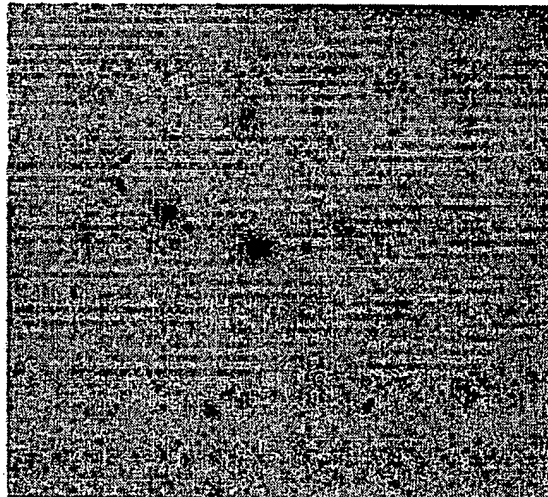
Fig. 2

PL IMAGE OF AS-GROWN DEFECTS IN CZ Si AFTER Fe CONTAMINATION 1×10^{11} atoms.cm⁻³
SCAN AREA 1mm x 1mm

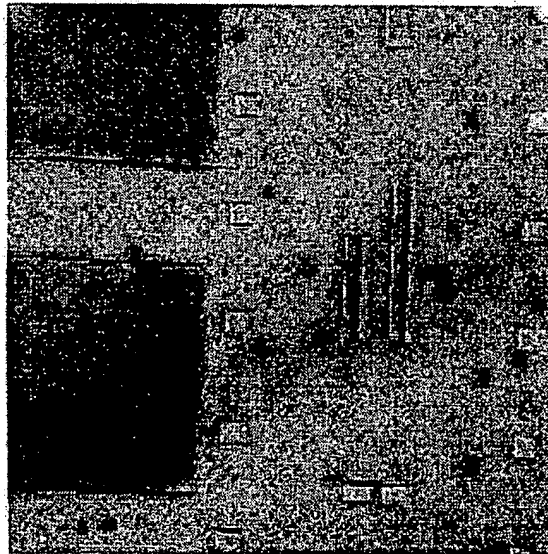
Fig. 4

PL IMAGE OF Ni SILICIDE PRECIPITATES IN CMOS PROCESSED TEST WAFER
SCAN AREA 500 x 500 μm

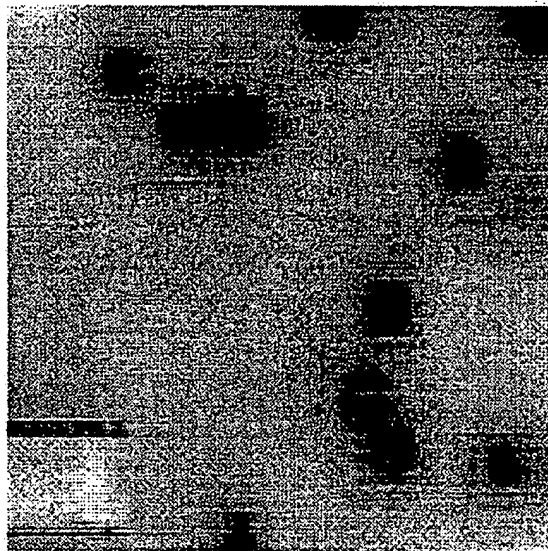
Fig. 5

PL IMAGE OF Cu SILICIDE PRECIPITATES IN CMOS PROCESSED TEST WAFER
SCAN AREA 100mm x 100 μ m

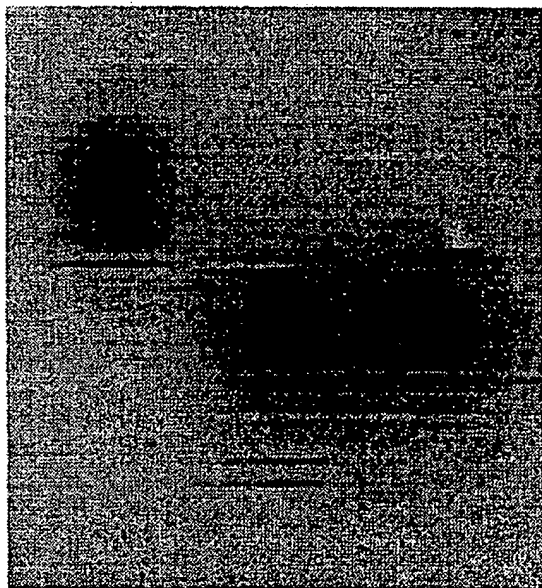
Fig. 6

PL IMAGE OF Cu SILICIDE PRECIPITATES IN CMOS PROCESSED TEST WAFER,
a) HIGH INJECTION, b) LOW INJECTION.
SCAN AREA 37 x 39 μ m

a)

b)

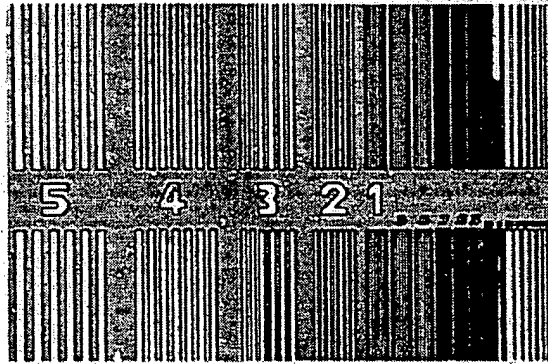
Fig. 7

MICROGRAPH OF LOCOS TEST STRUCTURE
SCAN AREA 120 x 60 μm

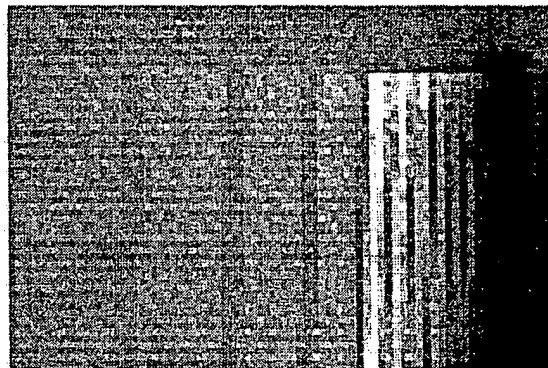
Fig. 8

PL IMAGE OF LOCOS TEST STRUCTURE REVEALING A HIGH DENSITY OF DISLOCATIONS
SCAN AREA 120 x 60 μm
